New York State Department of Transportation

Yellow Flag NB2358W005

BIN: 1065318

Location: Span 24, Girder G15 at Pier 23 above the right lane of 65th Street EB roadway between 4th and 5th Avenues.

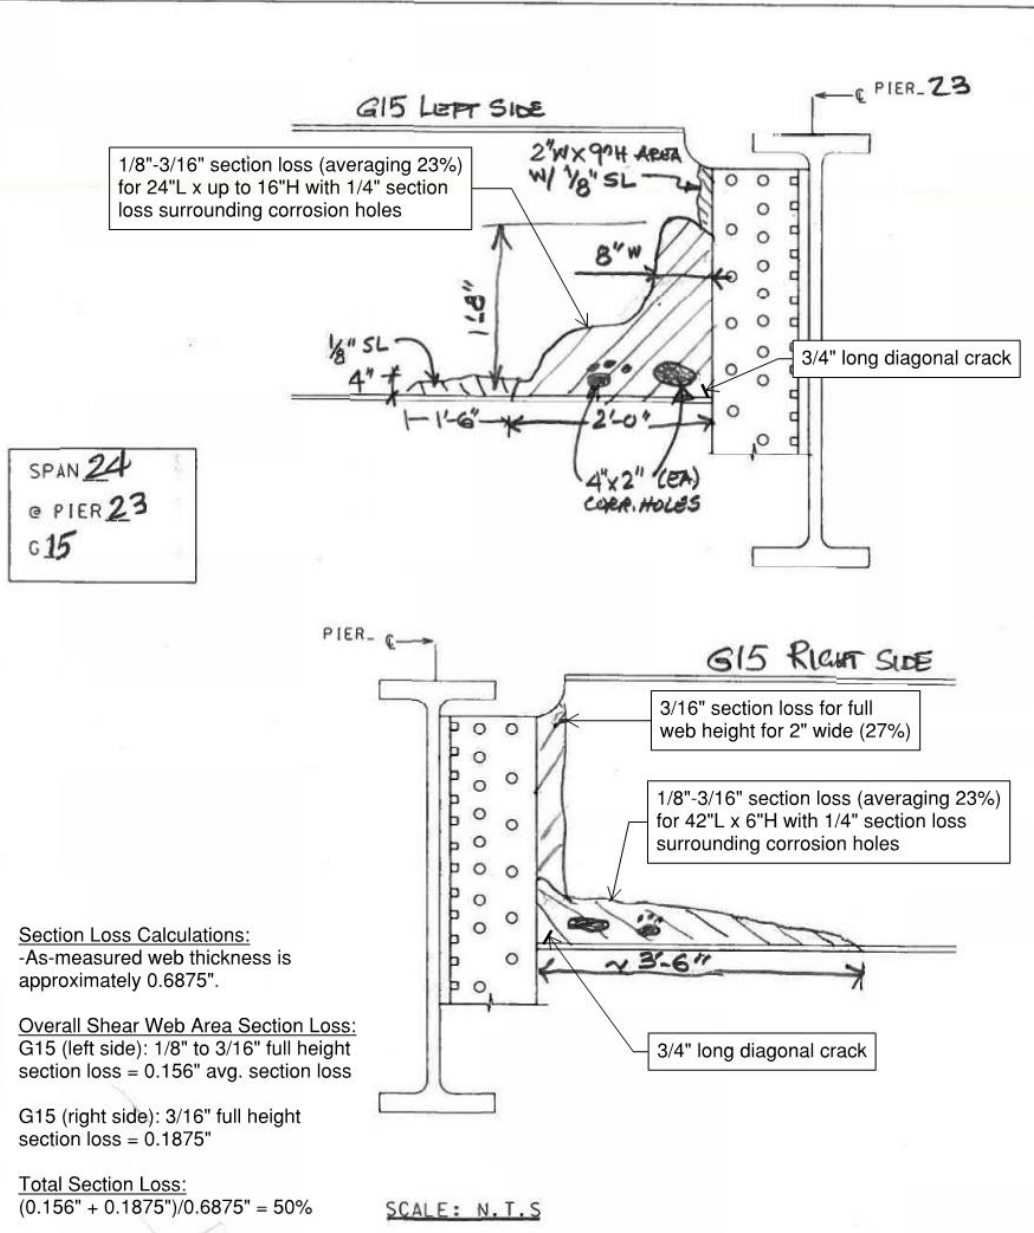
Photo Number: 2

Furthermore, in the lower web above the bottom flange in front of the pier, the girder web exhibits section loss 1/8"-3/16" deep (averaging 23%) for 24"L x up to 16"H at the left face, followed by 1/8" deep section loss (18%) for 18"L x 4"H. The right face of the girder in the lower web above the bottom flange also exhibits 1/8"-3/16" deep section loss (averaging 23%) for 42"L x 6"H. Within the section loss area in the lower web there are two corrosion holes for 4"W x 2"H each with 1/4" deep section loss surrounding the holes at each face of the girder. The total overall section loss along the lower web of the girder above the bottom flange is approximately 46%. (refer to Yellow Flag Condition sketch #2 for more details).

Attachment Description: Flag Condition Sketch

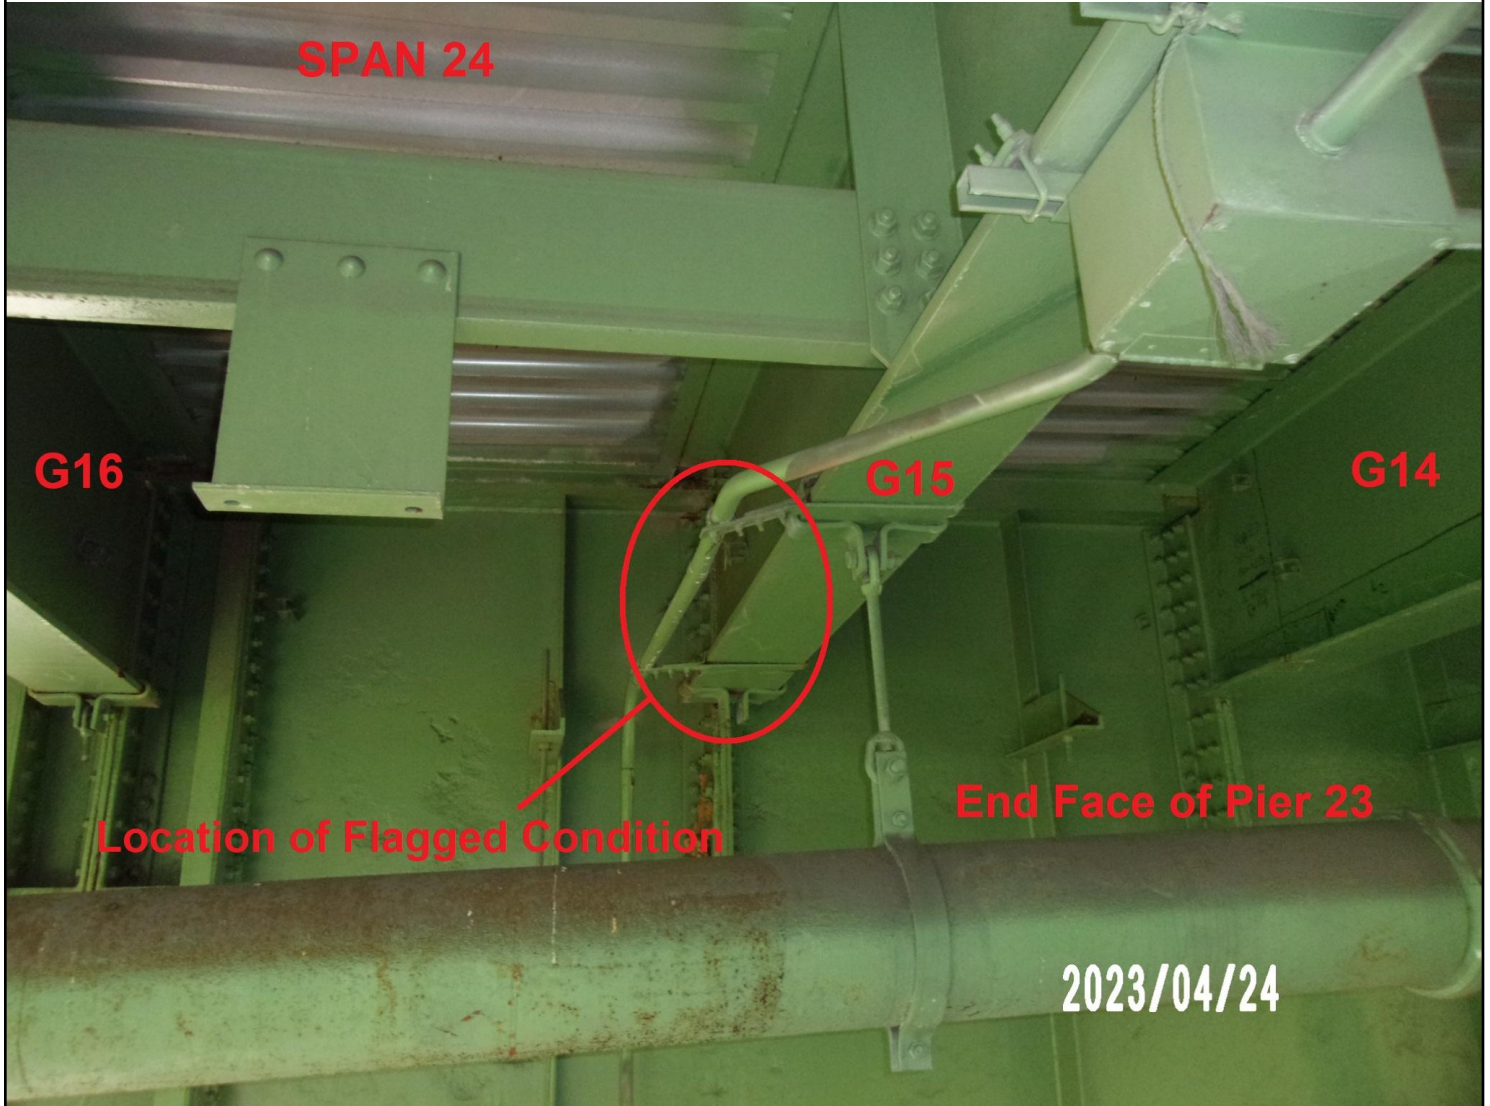
Photo Number: 3

Attachment Description: General view of the flagged condition at Girder G15 in Span 24 at Pier 23. Looking Begin.

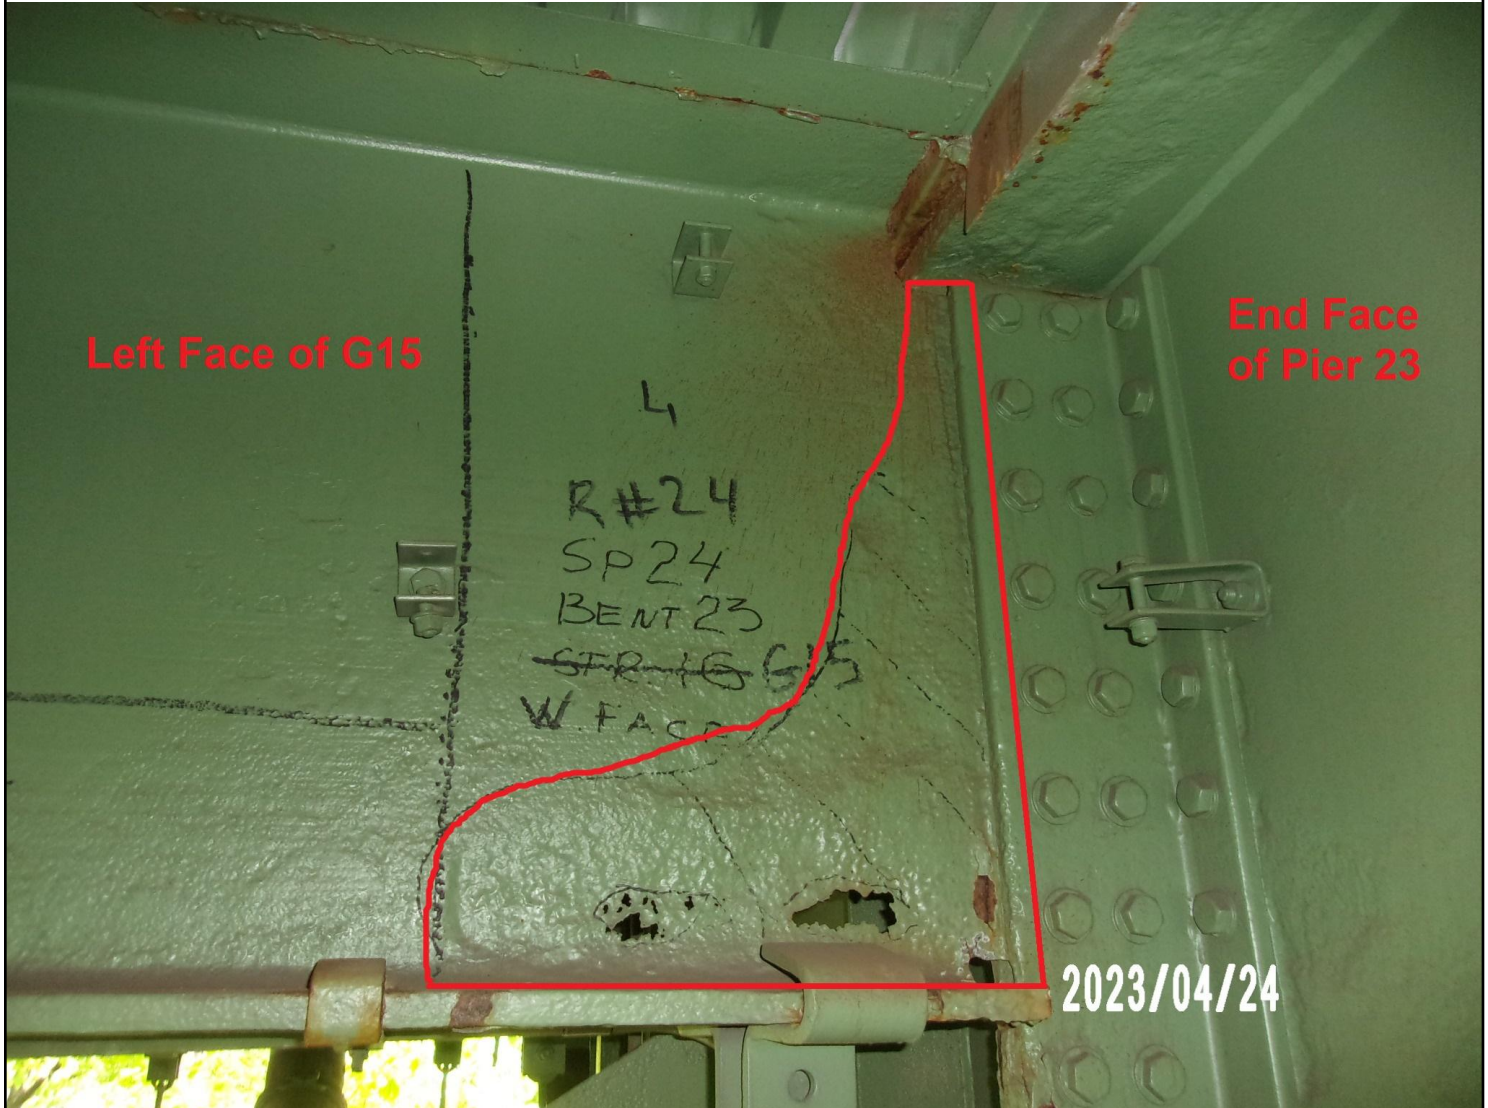
Photo Number: 4

In addition, the girder web in front of the connection to the pier exhibits section loss along the connection angle of 1/8"-3/16" deep (23% avg.) for the full height of the web in the left face and 3/16" deep section loss (27%) for the full height of the web in the right face, resulting in overall section loss in the web at the connection to the pier of approximately 50%. (Photos #4 and #5).

Attachment Description: The left face of Girder G15 in Span 24 at Pier 23. The girder web exhibits full height web section loss averaging 50% and 46% in the lower web above the bottom flange, with two corrosion holes in the lower web with 1/4" deep section loss surrounding the holes. Looking Right.

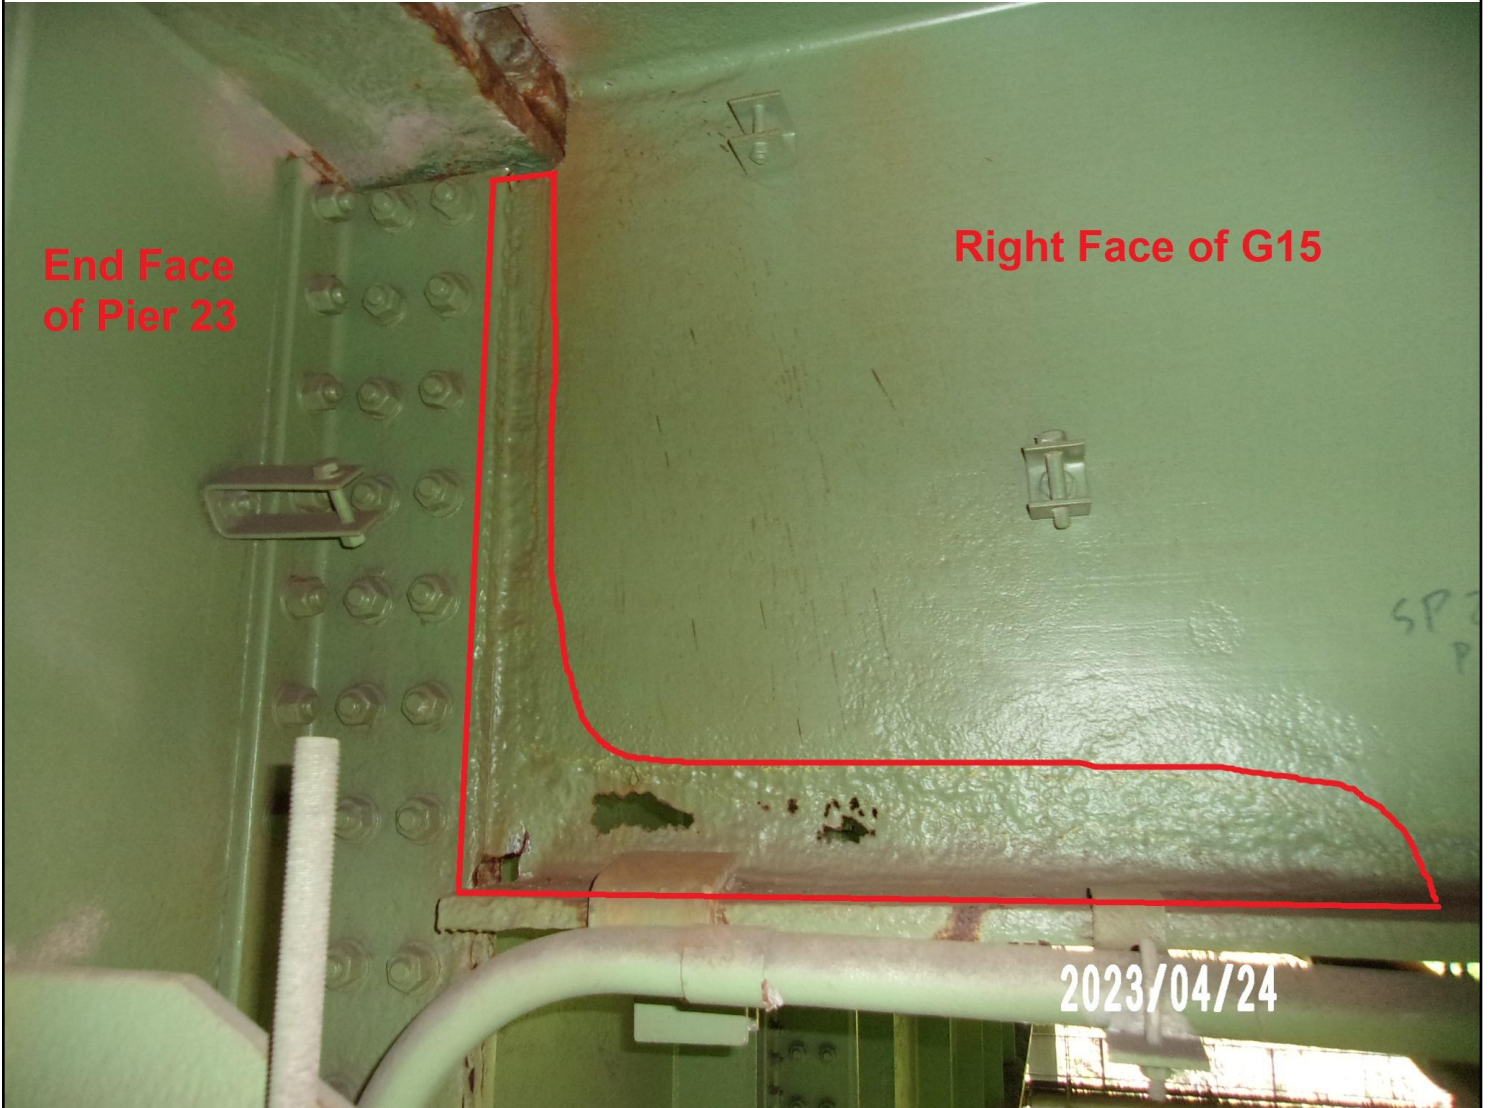
Photo Number: 5

Attachment Description: The right face of Girder G15 in Span 24 at Pier 23. The girder web exhibits full height web section loss averaging 50% and 46% in the lower web above the bottom flange, with two corrosion holes in the lower web with 1/4" deep section loss surrounding the holes. Looking Left.

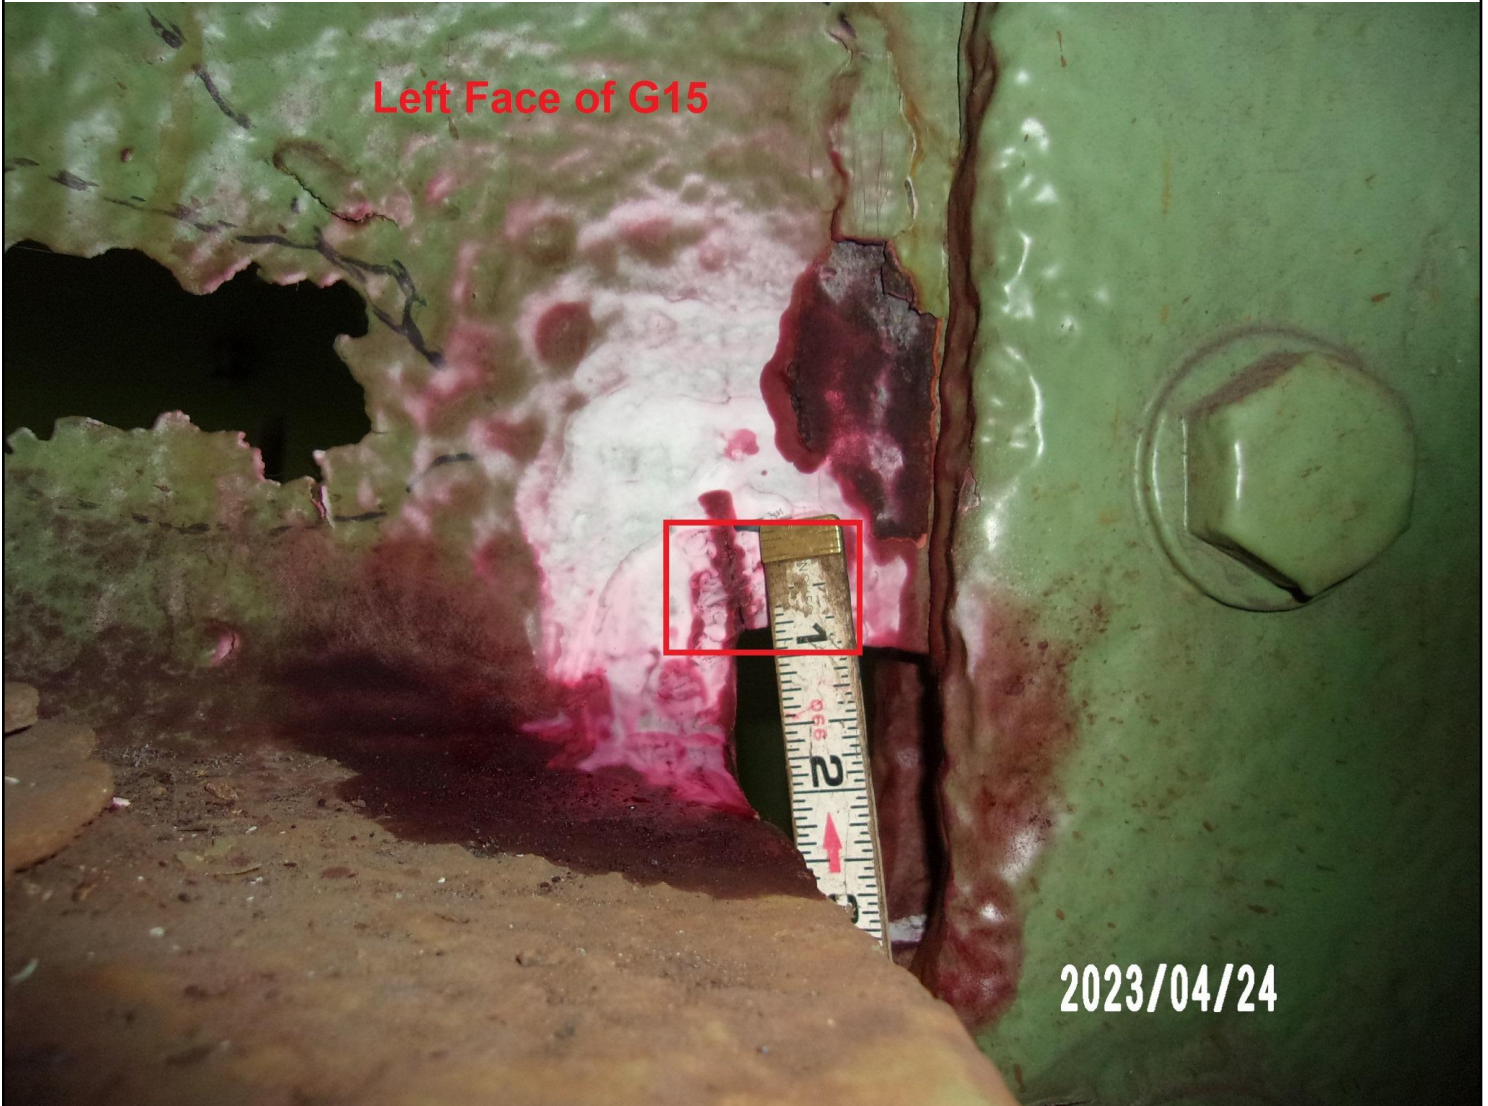
Photo Number: 6

The end of Girder G15 on Span 24 Side of Pier 23 exhibits a 3/4" long diagonal crack in the girder web stemming from the bottom cope of the girder (Photos #6 and #7).

Attachment Description: The left face of Girder G15 in Span 24 at Pier 23. The girder web exhibits 3/4" long diagonal crack stemming from the bottom cope. Looking Right.

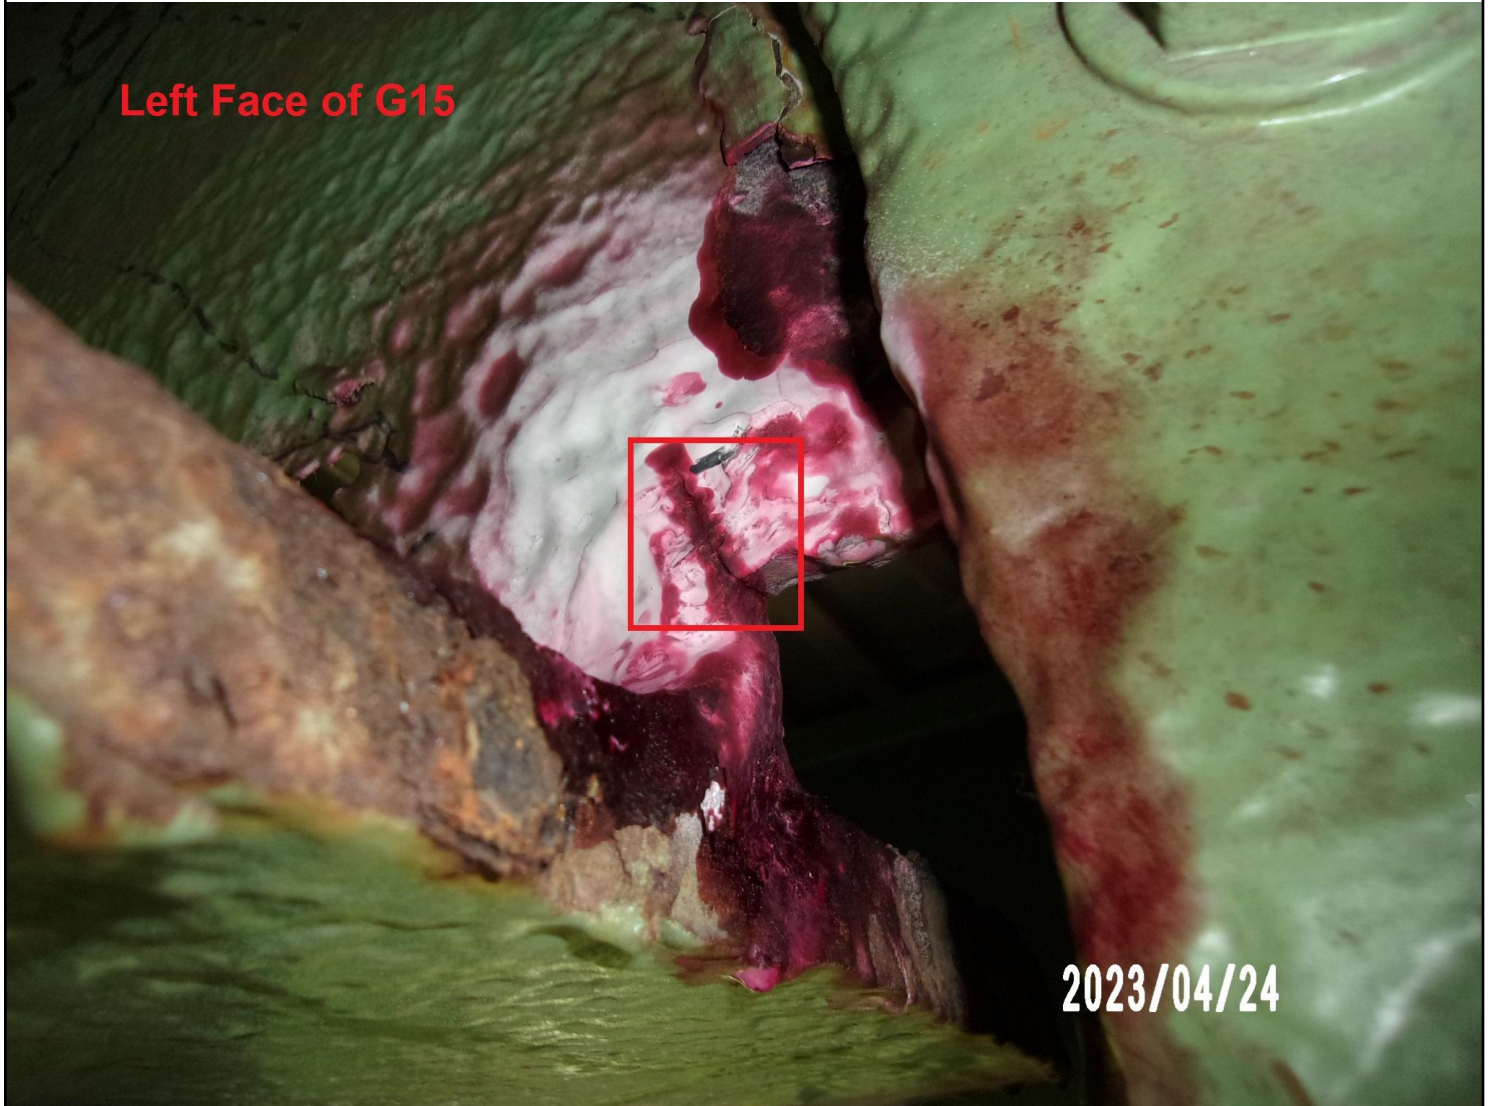
Photo Number: 7

Attachment Description: The left face of Girder G15 in Span 24 at Pier 23. Close up view of the 3/4" long diagonal crack in the girder web stemming from the bottom cope. Looking Right.
